Mirror artifact in obstetric ultrasound, an infrequent finding.

Cortejoso J, Crespo H, Ferrero A, Molpeceres I, Campillo F, Dos Santos R.

Servicio de Obstetricia y Ginecología. Hospital Clínico Universitario de Valladolid. Spain.

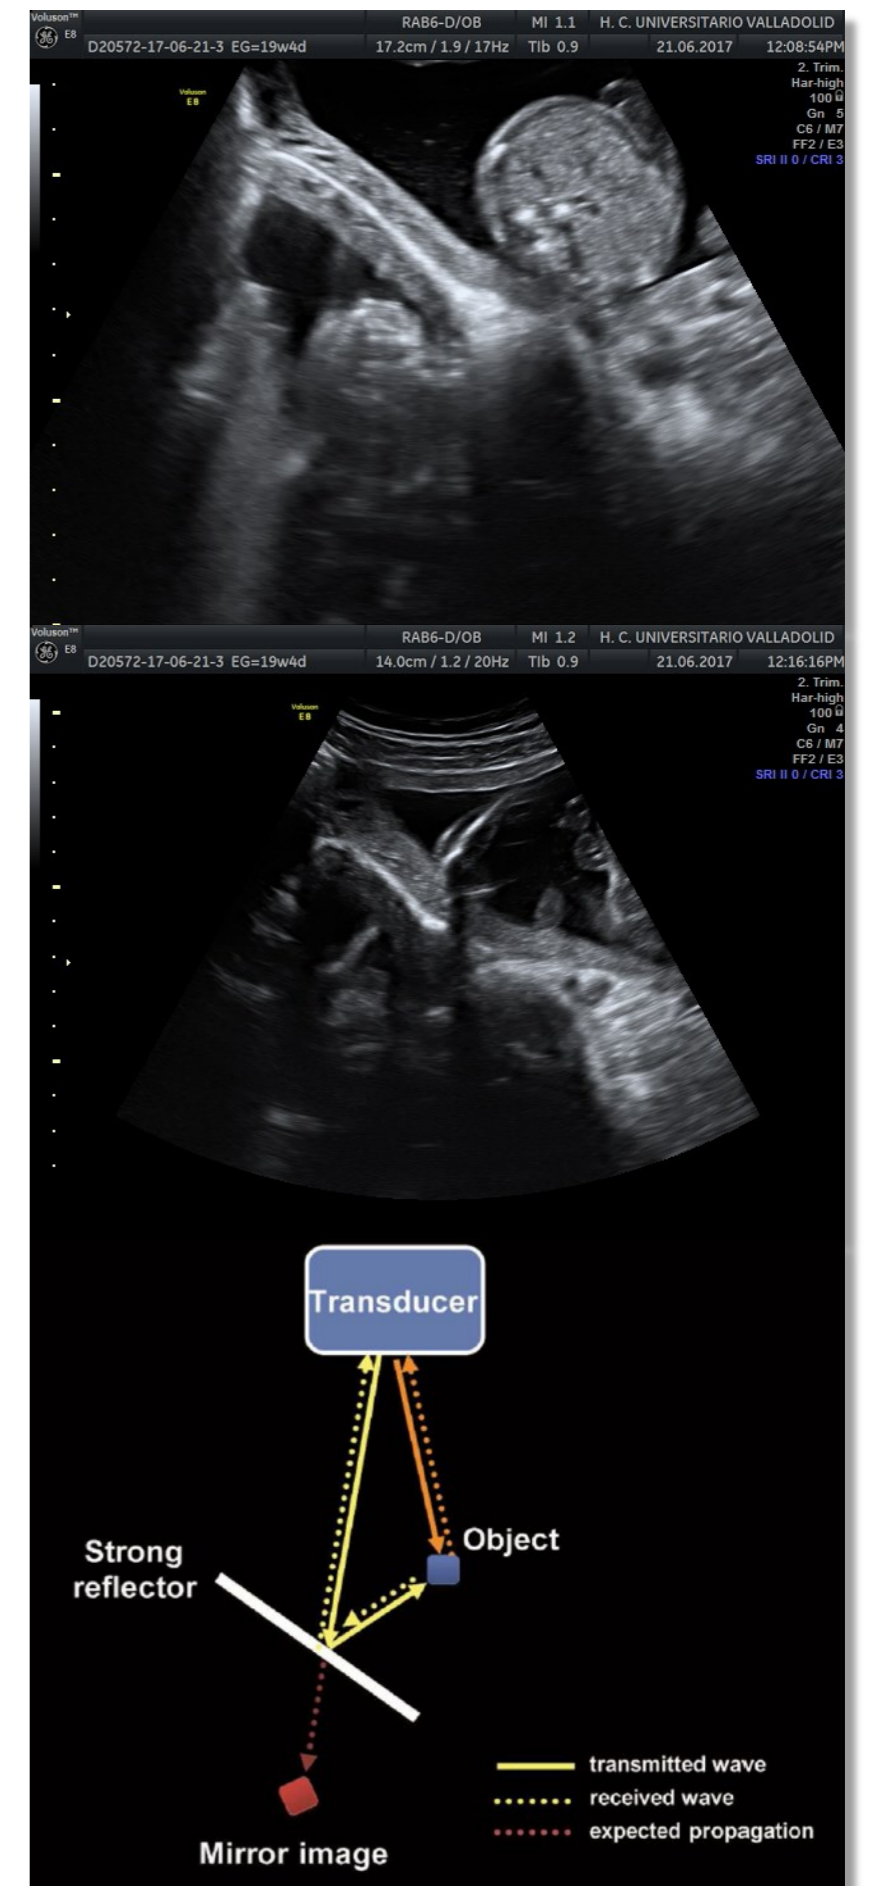
A 19⁺⁴ weeks pregnant woman comes to our Service to perform a prenatal diagnostic ultrasound, following the protocols established by the Sociedad Española de Ginecología y Obstetricia (SEGO). The ultrasound examination performed in the first trimester of pregnancy had been completely normal, dating the gestation by the measurement of the crown-rump length made in that exploration. Transabdominal ultrasound revealed an intrauterine pregnancy with fetal biometry according to gestational age and normal fetal anatomy. At certain moments of the scan, depending on the incidence angle of the ultrasound in the abdominal wall, an image suggesting the presence of an extrauterine gestational sac located laterally and behind the uterus containing fetal parts was noted. The image of this second fetus does not present the definition obtained for the first one, being impossible to assess its anatomy adequately. The movements of what looked like a second extrauterine fetus were synchronous with those of the intrauterine fetus, involving the same limbs, but in the opposite direction.

Given these findings, the diagnostic possibilities that could be considered at first sight were twin pregnancy with two amniotic sacs or abdominal ectopic/heterotopic pregnancy. The existence of a thick zone of separation between both possible gestational sacs, with a hyper-reflective line inside, accompanied by the synchrony of movements of both fetuses, made us suspect the presence of a mirror artifact. This was confirmed in subsequent scans, in which a single fetus was visualized, and after the delivery of a normal newborn.

Mirror image artifact is commonly seen in the liver leading to duplication of hepatic structures caused when the diaphragm acts as a strong reflector. It has been reported in vascular, abdominal, cardiac, and musculoskeletal ultrasound, but is very uncommon in obstetric ultrasound, having been published, to the best of our knowledge, exclusively on four occasions (three of them in early pregnancies). In these cases, the psoas muscle acts as a reflective surface when the bladder is over distended and the uterus is pushed up into the abdomen. At more advanced gestational age, as in our case, the reflective surface is caused by the presence of gas and fluid in the bowel.

Ultrasound artifacts are created by the machine's interpretation of returning echoes but do not correspond to the actual anatomy of the patient. These artifacts are often misleading and result in misdiagnosis. Physicians must be cognizant of mirror artifact to avoid a false positive misdiagnosis of heterotopic or twin pregnancy. Once identified, can be decreased or eliminated by moving the transducer to center it on the region of interest and/or placing the focal zone at the level of interest in the real structure.
